DAM INSPECTION CHECKLIST POSSUM POINT POWER STATION POND ABC

INSPECTION DATE: JANUARY 12, 2016

INSPECTED BY: K. ACREE

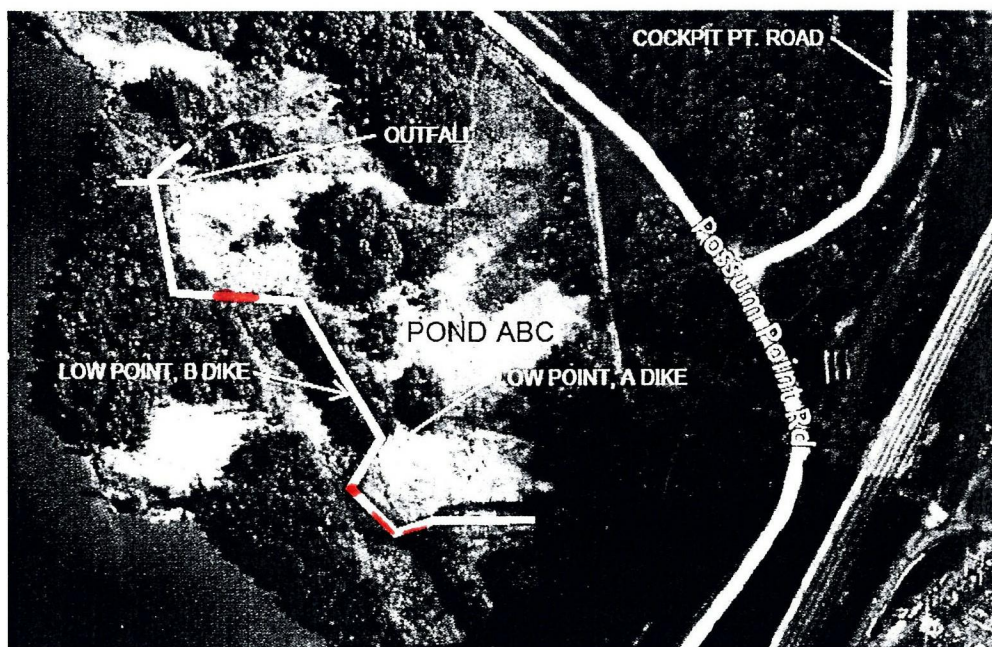
* See figure below.

- LOW POINT, C DIKE - SAND BAGS DO NOT HAVE STANDING WATER AGAINST THEM, AND SEVERAL SAND BAGS ARE RIPPED, AND SAND BAGS ARE IN PLACE.
- STANDING WATER PRESENT ON EMBANKMENT, AS NOTED ON DRAWING BELOW.
- STANDING WATER IS PRESENT AT THE TOE OF EMBANKMENT, WITHIN POND A. (TYPICAL OF PONDS B AND C, AS WELL)
